### STUDIES OF SETTLEMENT AND SEEPAGE AT CLARK HILL DAM DURING AND AFTER CONSTRUCTION

by Frank M. Bell

## STUDIES OF SETTLEMENT AND SEEPAGE AT CLARK HILL DAM DURING AND AFTER CONSTRUCTION

Frank M. Bell, Assoc. M. ASCE  
Chief Soil Mechanics Br.,  
So. Atlantic Div. Laboratory, Corps of Engrs.,  
U. S. Army, Marietta, Georgia

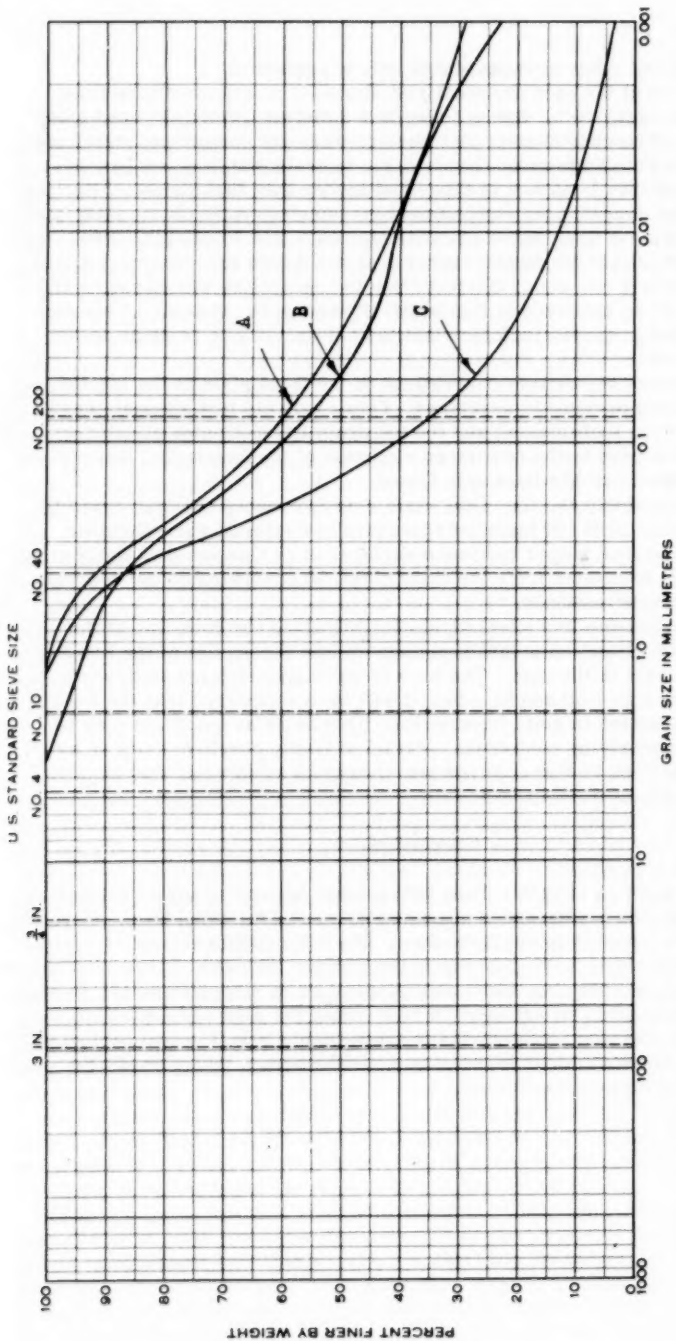
Sample No.	COBBLES	GRAVEL		SAND			SILT OR CLAY
		Coarse	Fine	Coarse	Medium	Fine	
Sample No.	CLASSIFICATION	NatWC	LL	PL	PI		Project
A	ML - sandy silt	21	38	32	6	Micaceous	CLARK HILL DAM
B	CL - sandy clay	23	48	27	21	n	TYPICAL EMBANKMENT SOILS Fig.-1
C	SW - silty sand	10			NP	n

The major portion of the fill materials were obtained from areas having the same general characteristics of the abutment foundations previously described. Properties of typical materials are shown in figure 1. It was found that the permeability characteristics of the lean clays and highly micaceous silty soils were comparable. The dam was designed as if it were homogeneous in this respect. However, during construction, efforts were made to place the sandier soils near the outer section.

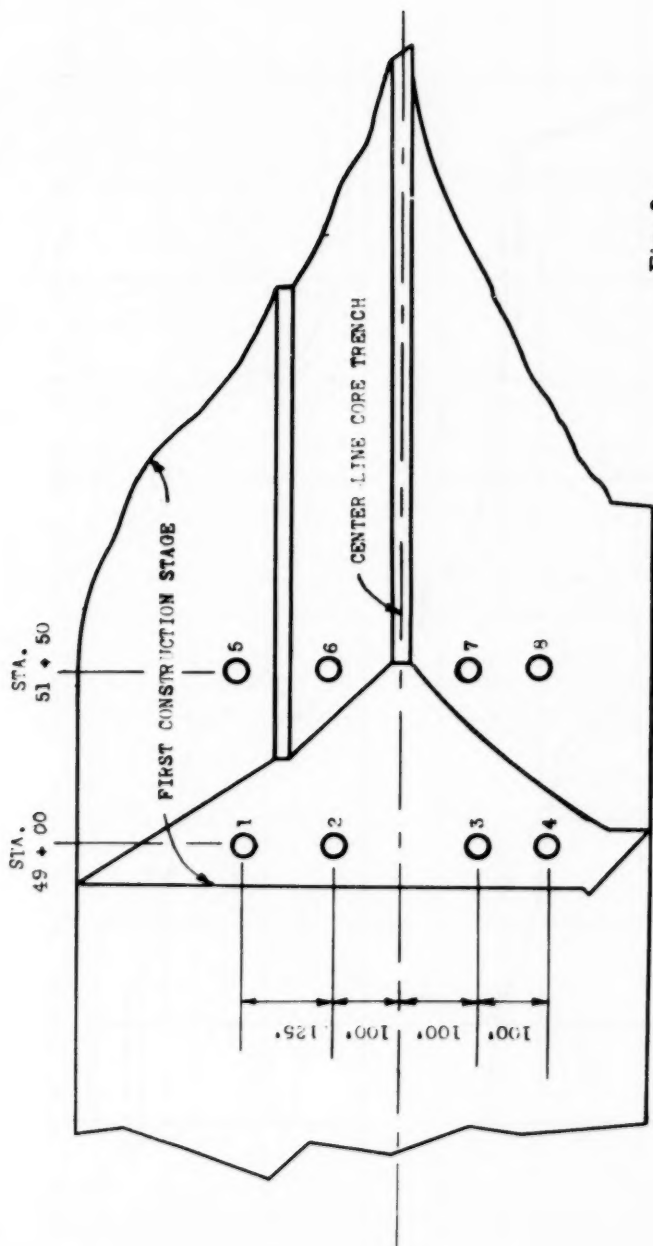
Fig.-2  
LOCATION PLAN  
SETTLEMENT PLATES  
CLARK HILL DAM  
Scale: 1" = 200'

Figure 2 shows the location of these plates. The first construction stage began in September 1947 and was completed about September 1948. It will be noted that plates 1 through 4 were located near the toe of the slope during this period and consequently received little surcharge. The second stage began July 1950 and was completed about November of that year. Observations were made periodically during this time.

The riser on plate 4 was damaged in the early stages of construction. The action of the remainder is shown in figures 3 and 4. The pattern of all is similar. The observations confirmed predictions with respect to both rate and magnitude of settlement.
